TECHNICAL APPENDICES
DRAFT SUBSEQUENT ENVIRONMENTAL IMPACT REPORT

SIERRA STAR MASTER PLAN PROJECT

**TECHNICAL APPENDICES
SIERRA STAR MASTER PLAN
DRAFT SUBSEQUENT ENVIRONMENTAL IMPACT REPORT**

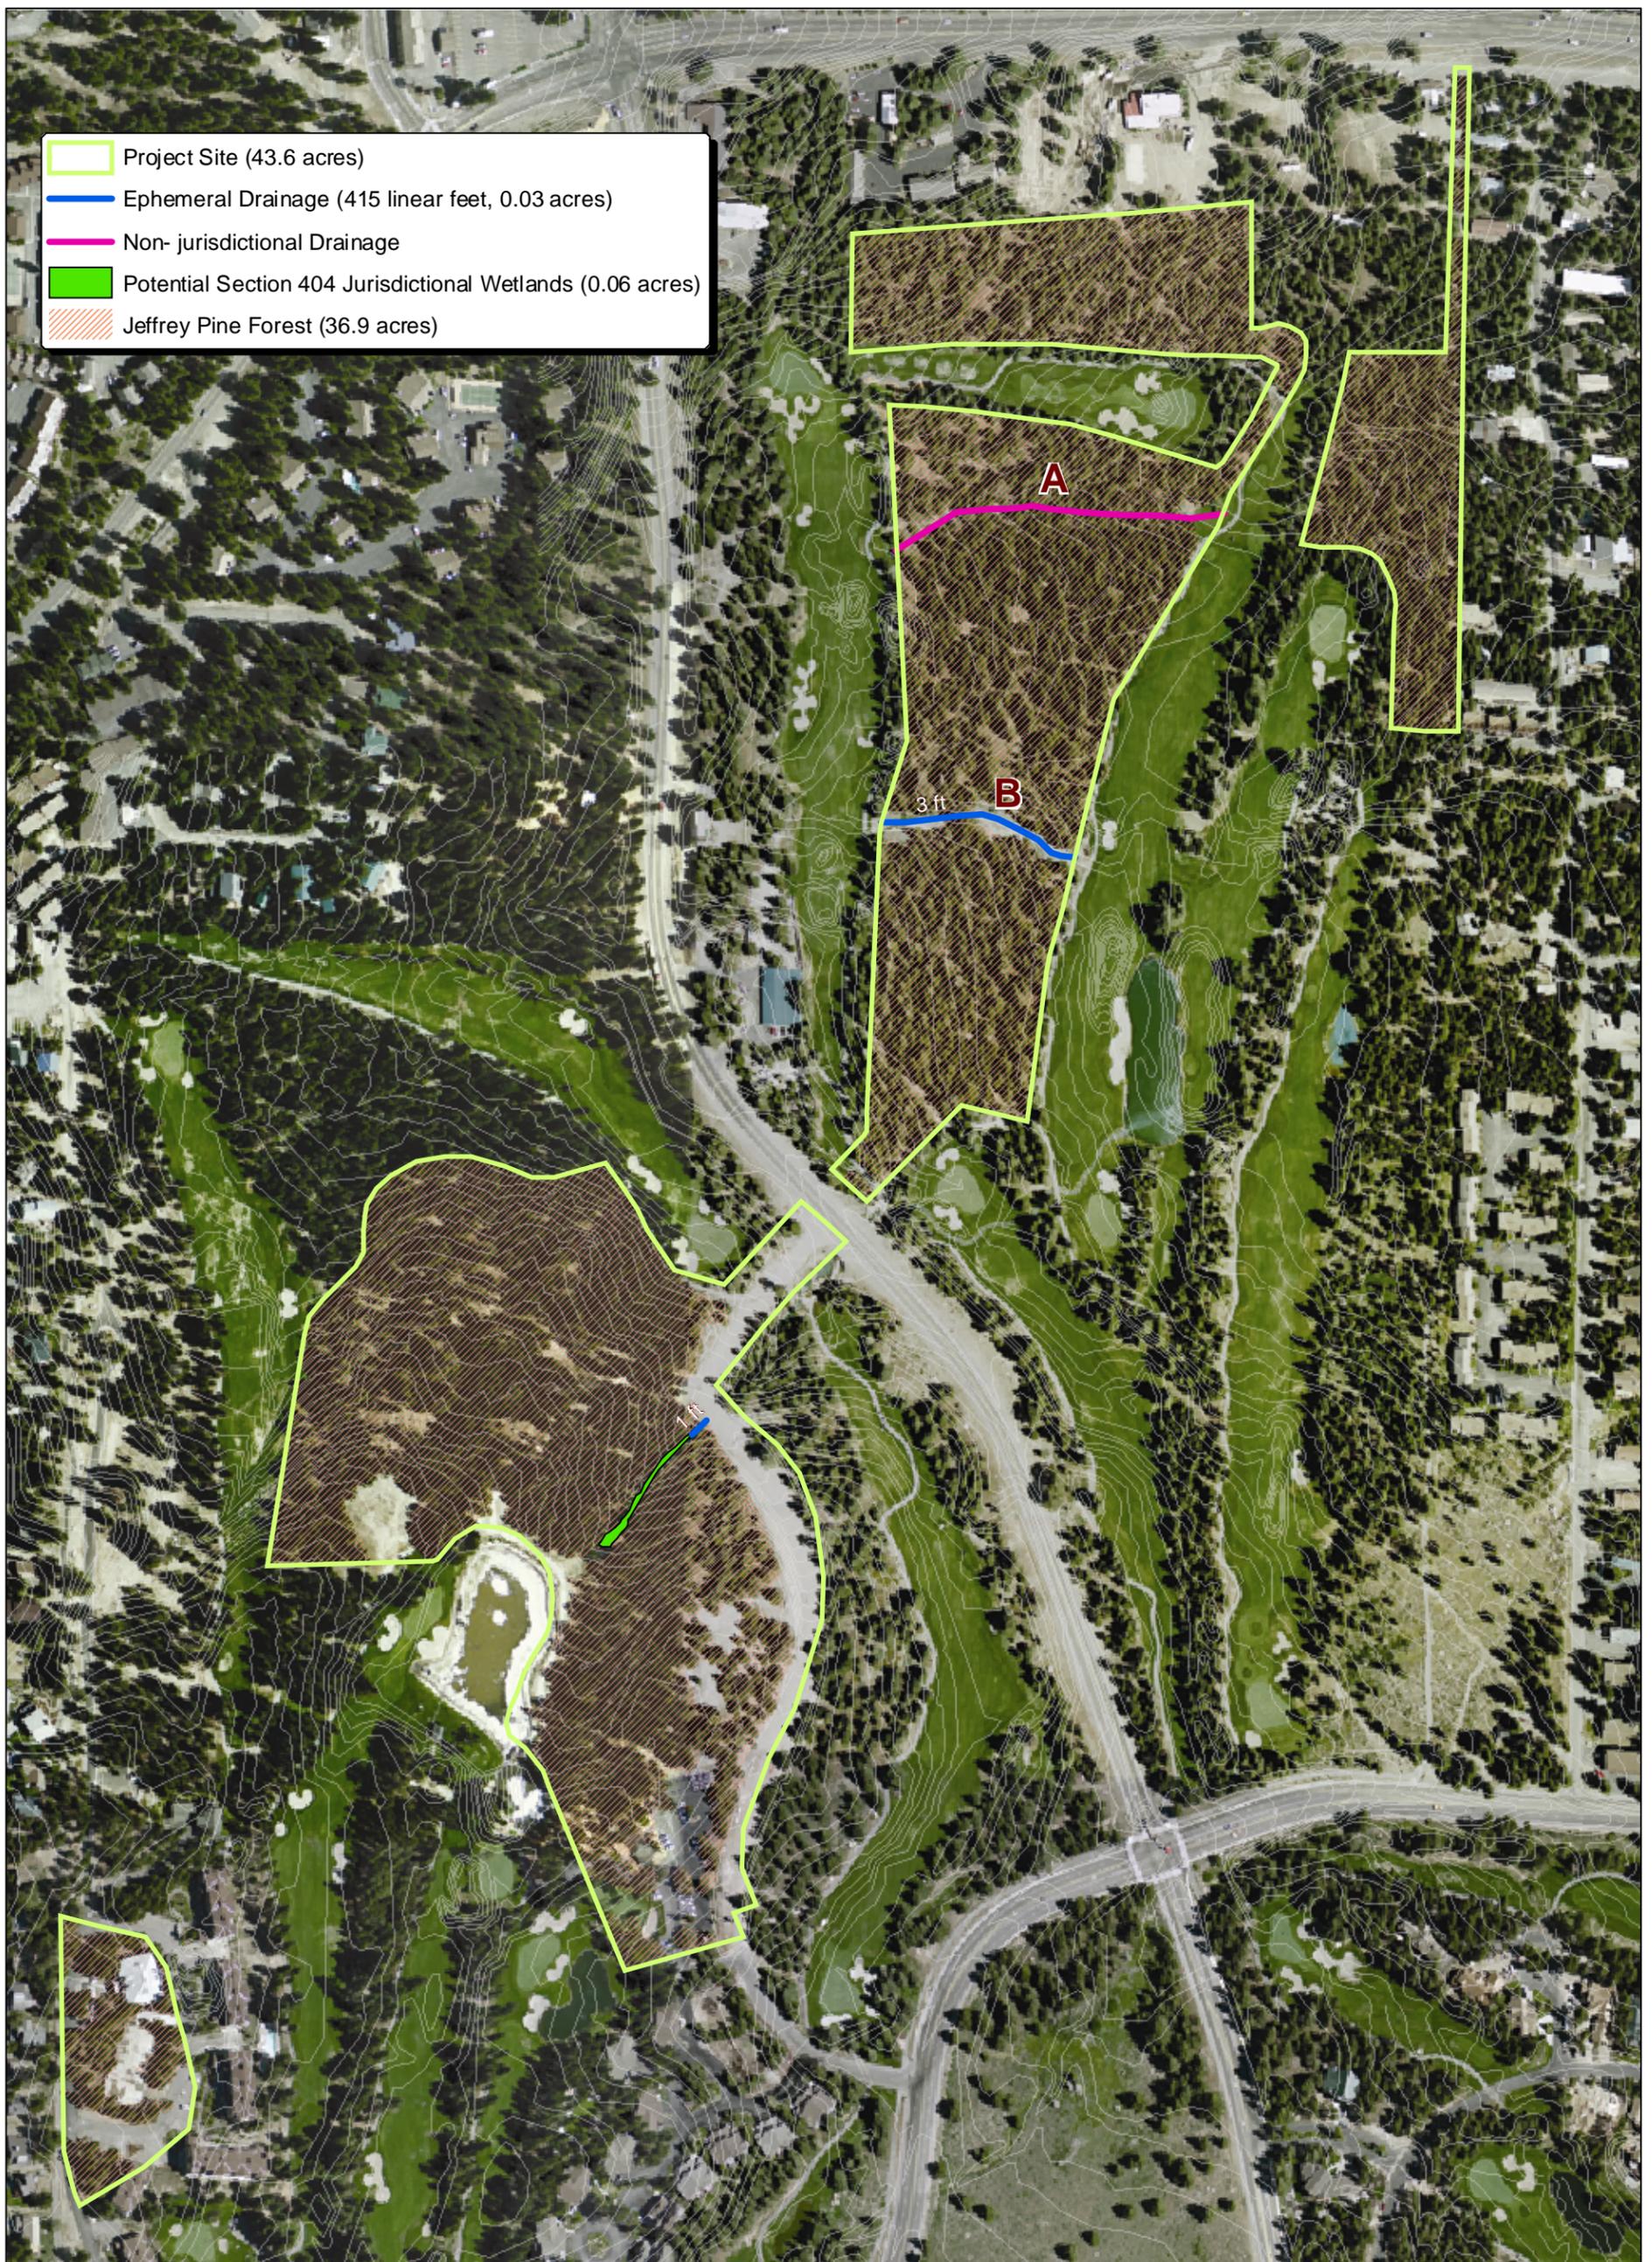
Figure 2.
Map of Plant Communities and
Aquatic Features Within the Project Site

Two unnamed streams were observed in the Project Site, identified on Figure 2 as Drainage A and Drainage B. Drainage A is a hydrologically isolated, remnant channel that may have been connected to the stormwater system. This feature did not exhibit any connection to a Water of the U.S. Drainage A did not contain well-defined bed and bank topography and did not exhibit signs of recent flow, such as sediment deposits or scour. Accumulation of pine cones and leaf litter also indicate that the feature did not convey water during the recent spring runoff resulting from snow melt.

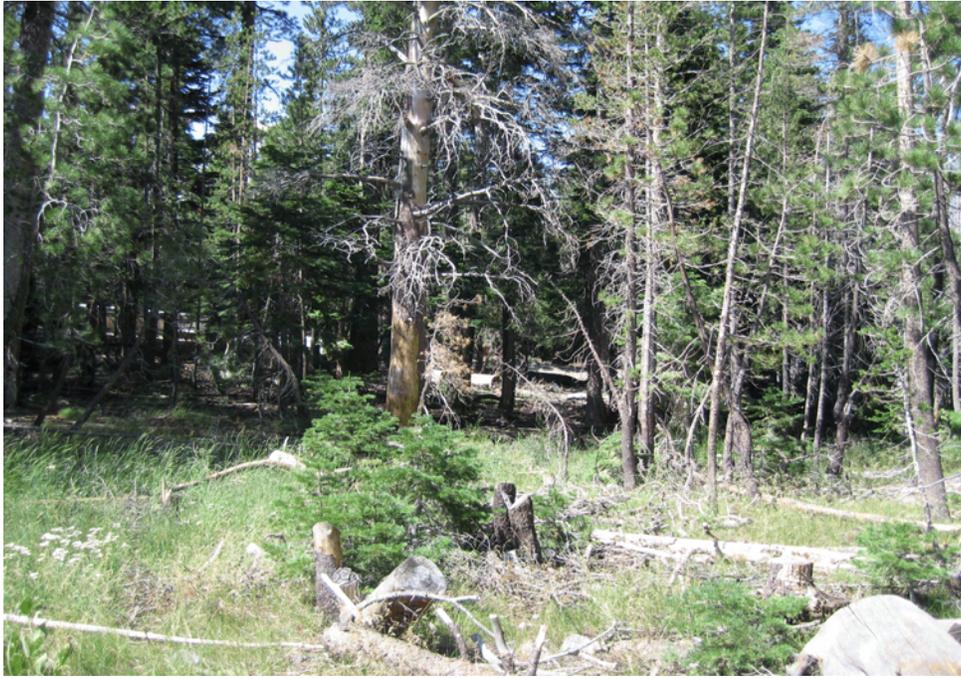
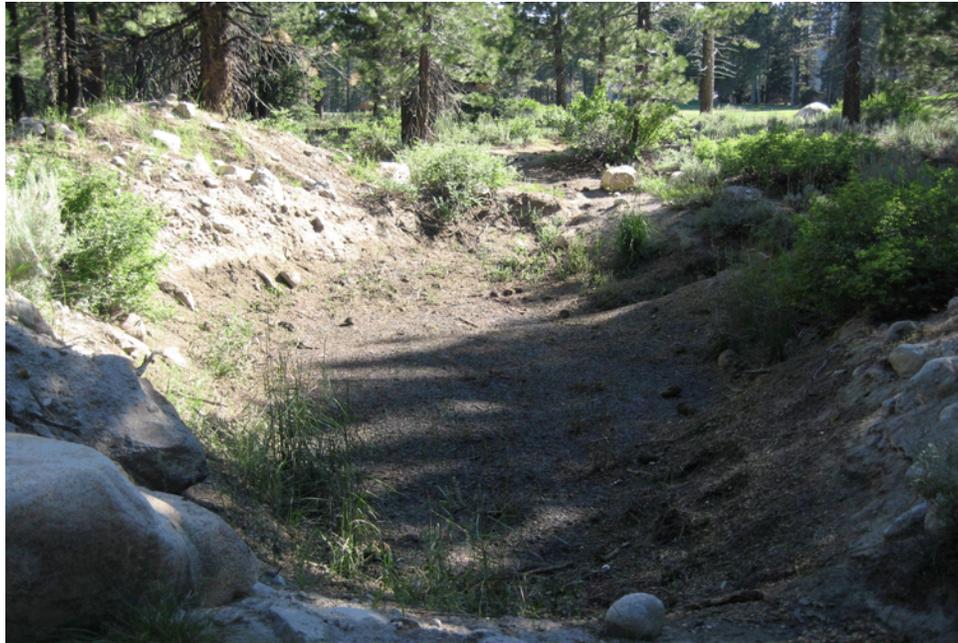
Above: Typical Jeffrey pine forest habitat found within the Project Site.

Below: Detention basin located along Drainage A (Figure 2).

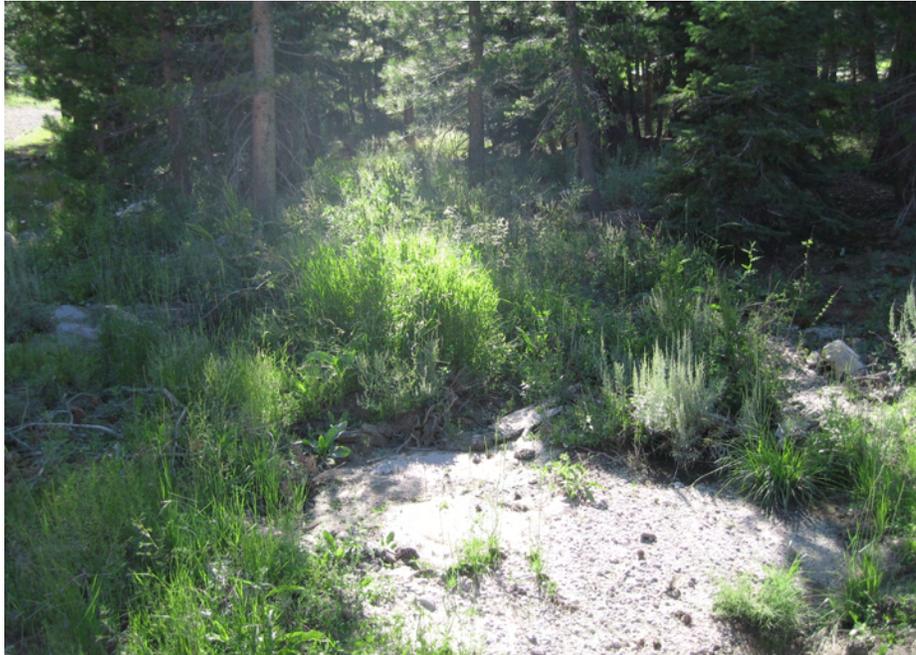
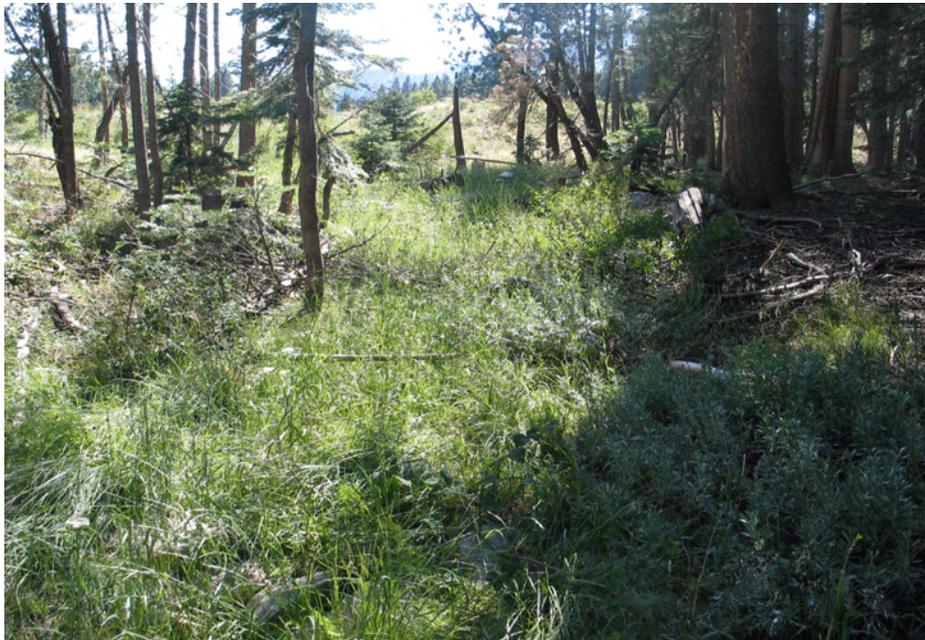
Above: Ephemeral Drainage B

Below: Potential wetland observed south of Minaret Road.

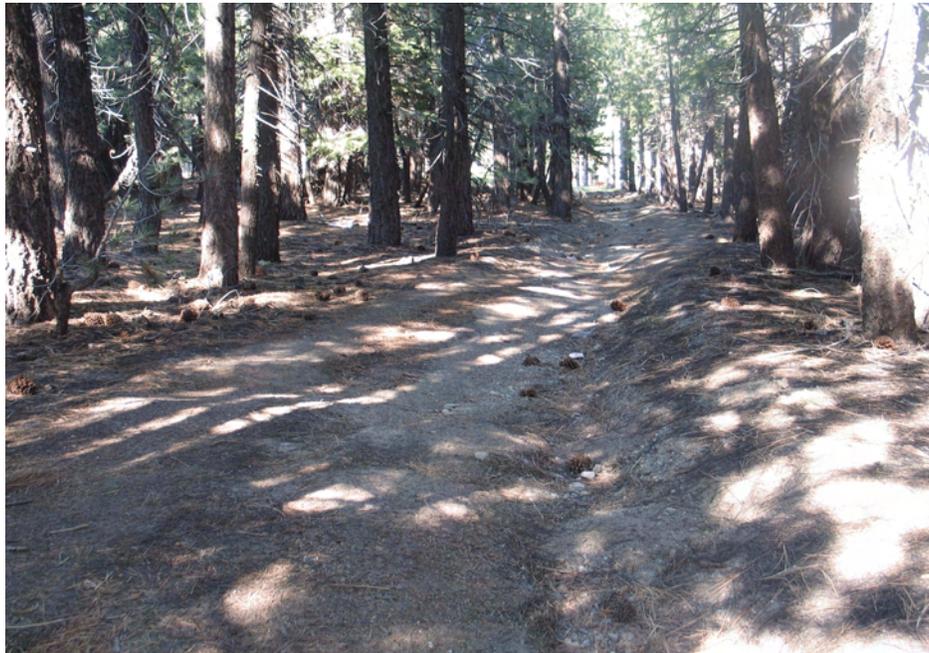
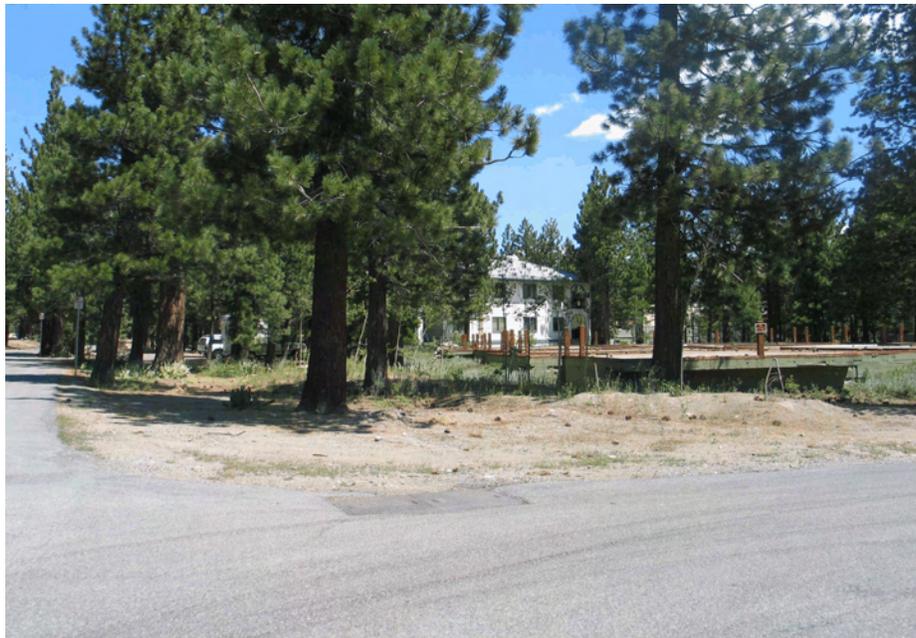
Above: Non-jurisdictional Drainage A; note lack of bed-and-bank topography and OHW mark.

Below: Jeffrey pine forest surrounded by development in southwestern portion of Project Site.

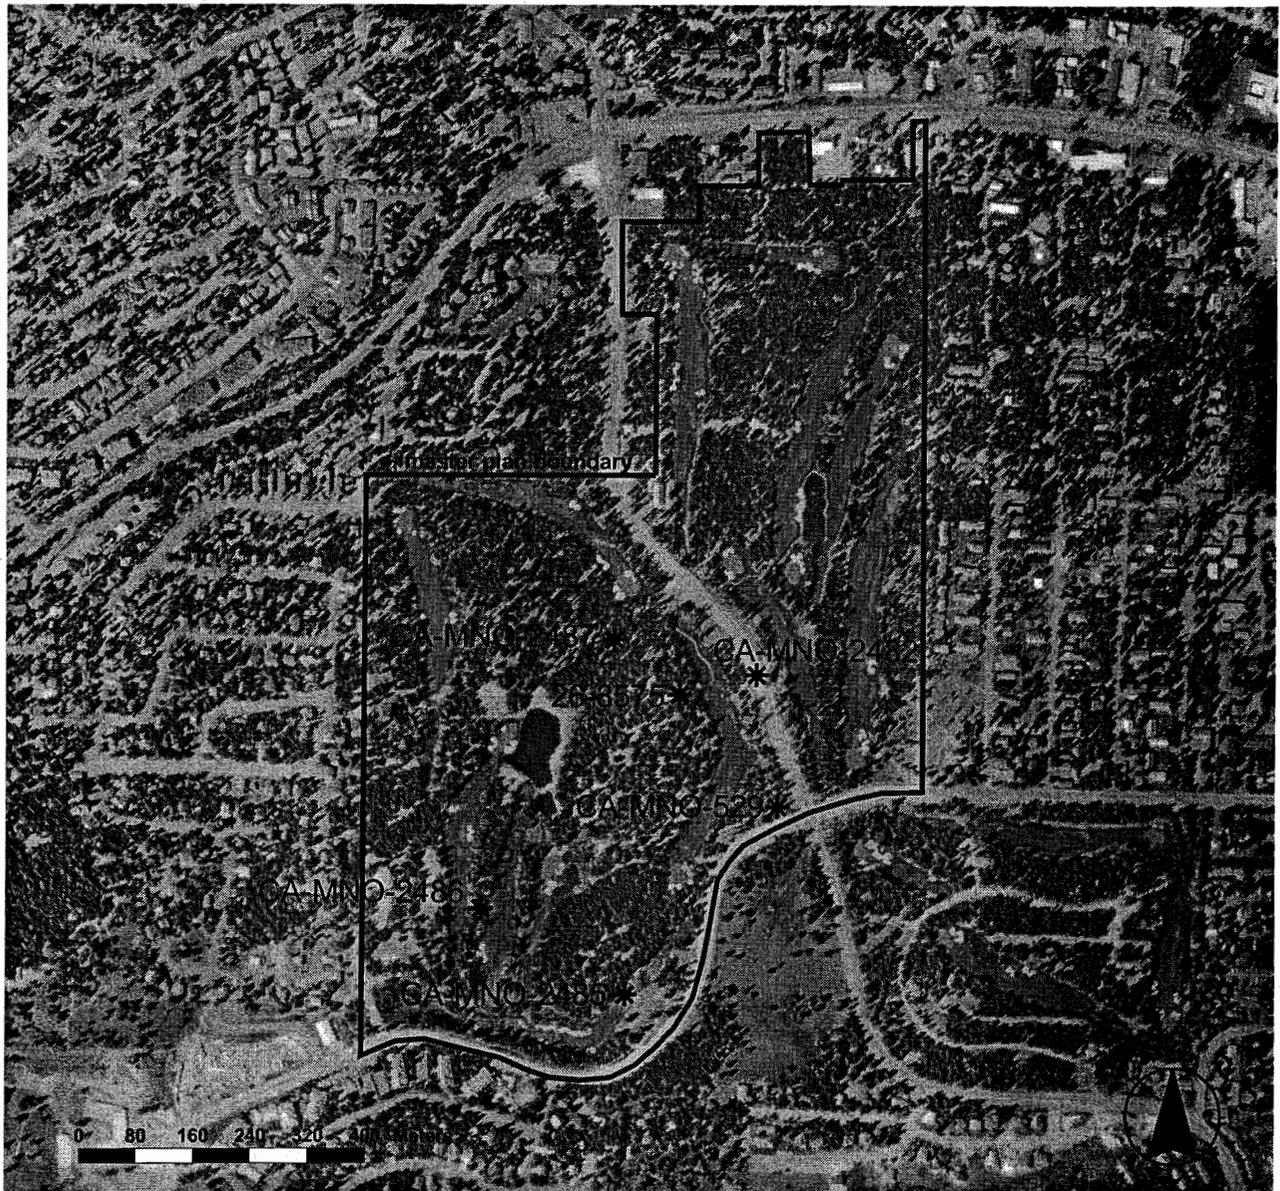
Map 1. Archaeological Site Locations (adapted from USGS 7.5' orthophoto quad Old Mammoth SW, Calif. 1998).

selected artifacts were photographed. With today's GPS technology, it was determined that the site had been originally misplotted by a little over 200 m (Map 1). The discrepancy is not surprising, given that the relatively level terrain and forest vegetation provide few distinctive topographic clues for plotting.

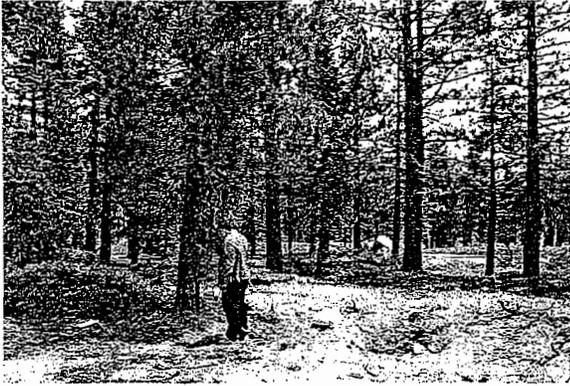
Figure 1. Site overview; percolation test to right, artifact scatter to left.

During the June 30th assessment, the site location was examined by the author and one assistant. Present during the work were Scott Schoenfeld of Intrawest and Dave Early, forestry consultant for the project. Mr. Early had seen the site previously, and could locate it on the ground. The site's location was found to have been disturbed by a percolation test pit, reported to have been excavated in October 2003. In fact, only a couple of artifacts were visible on the ground surface; the site location was verified by the presence of the shallow depression, which matched photographs in the original site record (Figures 1 and 2).

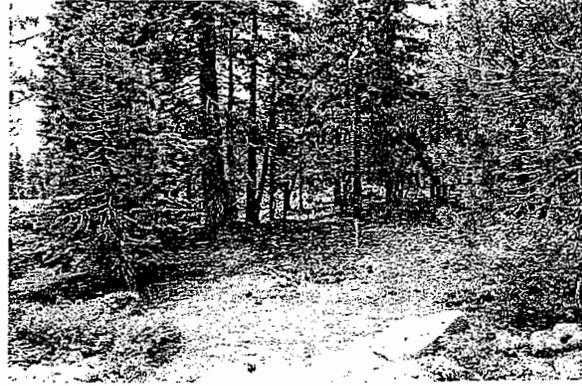
Figure 2. Depression.

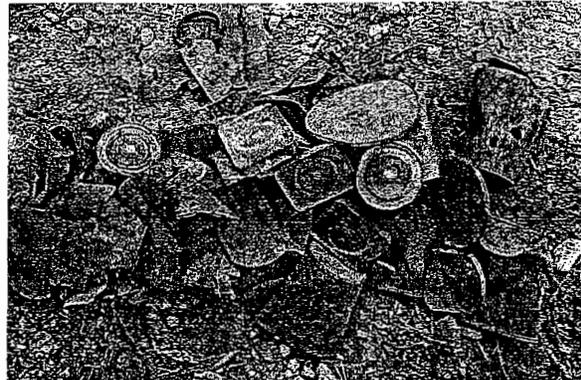
Figure 7. Cans from surface scrape.

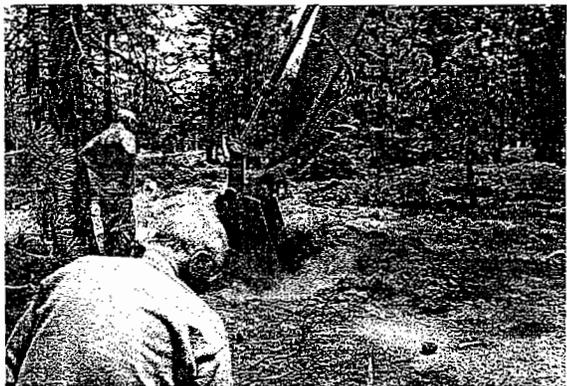
Figure 8. Excavation of Test Pit A.

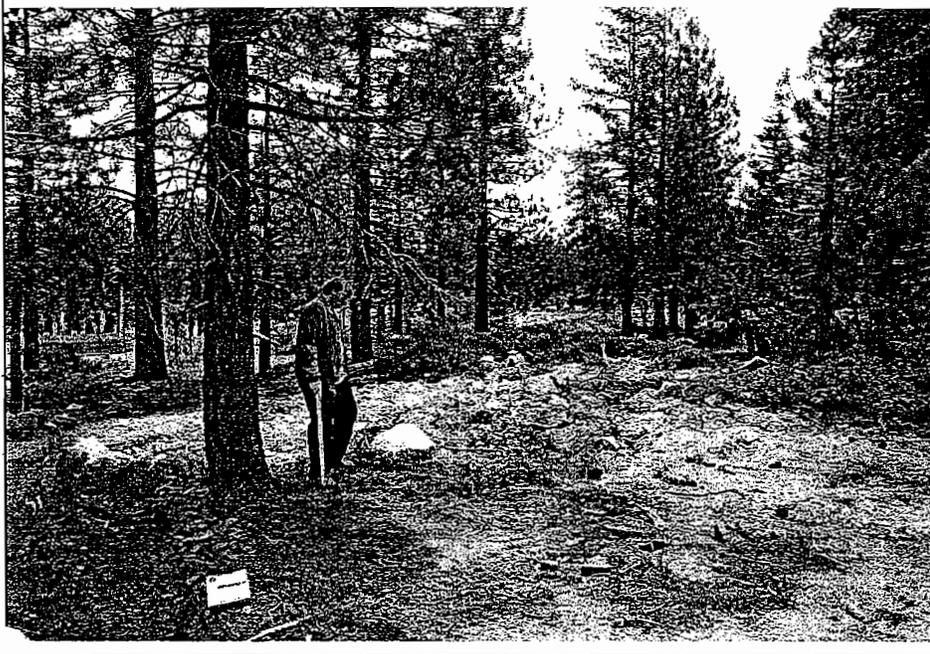
Overview of site area towards the southeast, artifact scatter is located between the person and the clipboard (in foreground).

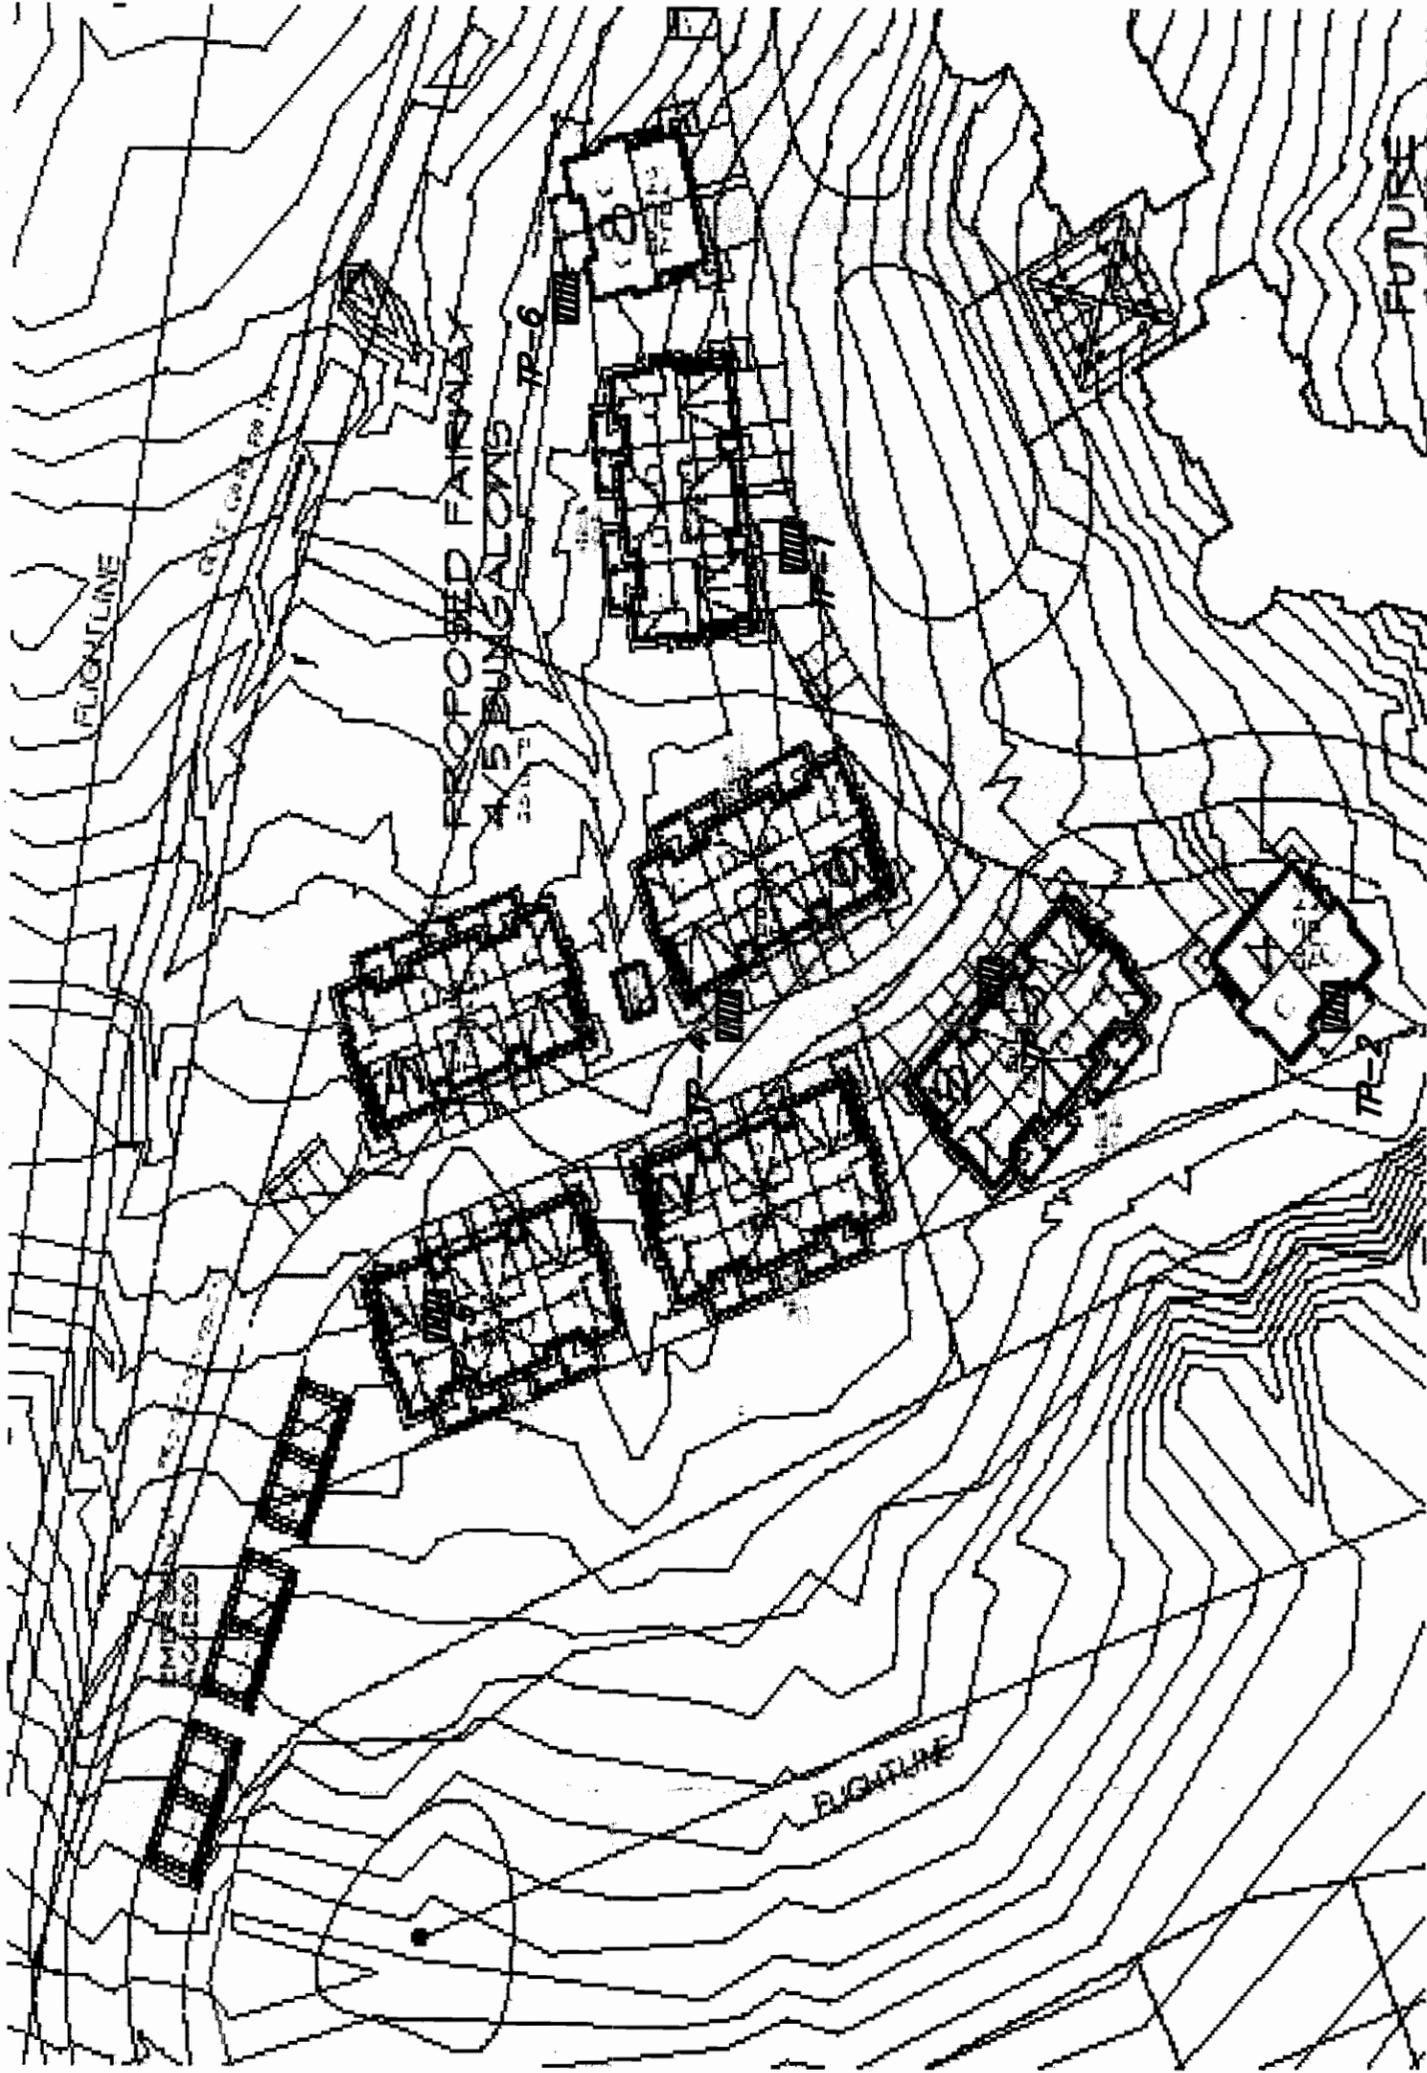
PROJECT:	SUSURFACE GEOTECHNICAL MAP FAIRWAY 4/5 BUNGALOWS		
SCALE:	N.T.S	DATE:	10/2004
DRAWING:	FIG3.DWG	DRAWN BY:	JAA
JOB NO.:	3.30554	FIGURE:	FIGURE 3

Glacial Till deposits were encountered in all the test pits below the alluvium. In general, the Glacial Till deposits consisted of a light brown to gray and reddish-brown, moist, medium dense to dense, very fine to coarse SAND (Unified Soil Classification Symbols: SM and SP-SM), with few to abundant gravels, cobble clasts and boulders to approximately 36-inches diameter. The Glacial Till was moderate to well indurated at depth. Backhoe refusal was encountered at approximately 7-feet in TP-6. The total thickness of this deposit was not determined during this investigation. This deposit is considered suitable for additional fill and/or structural support provided the earthwork

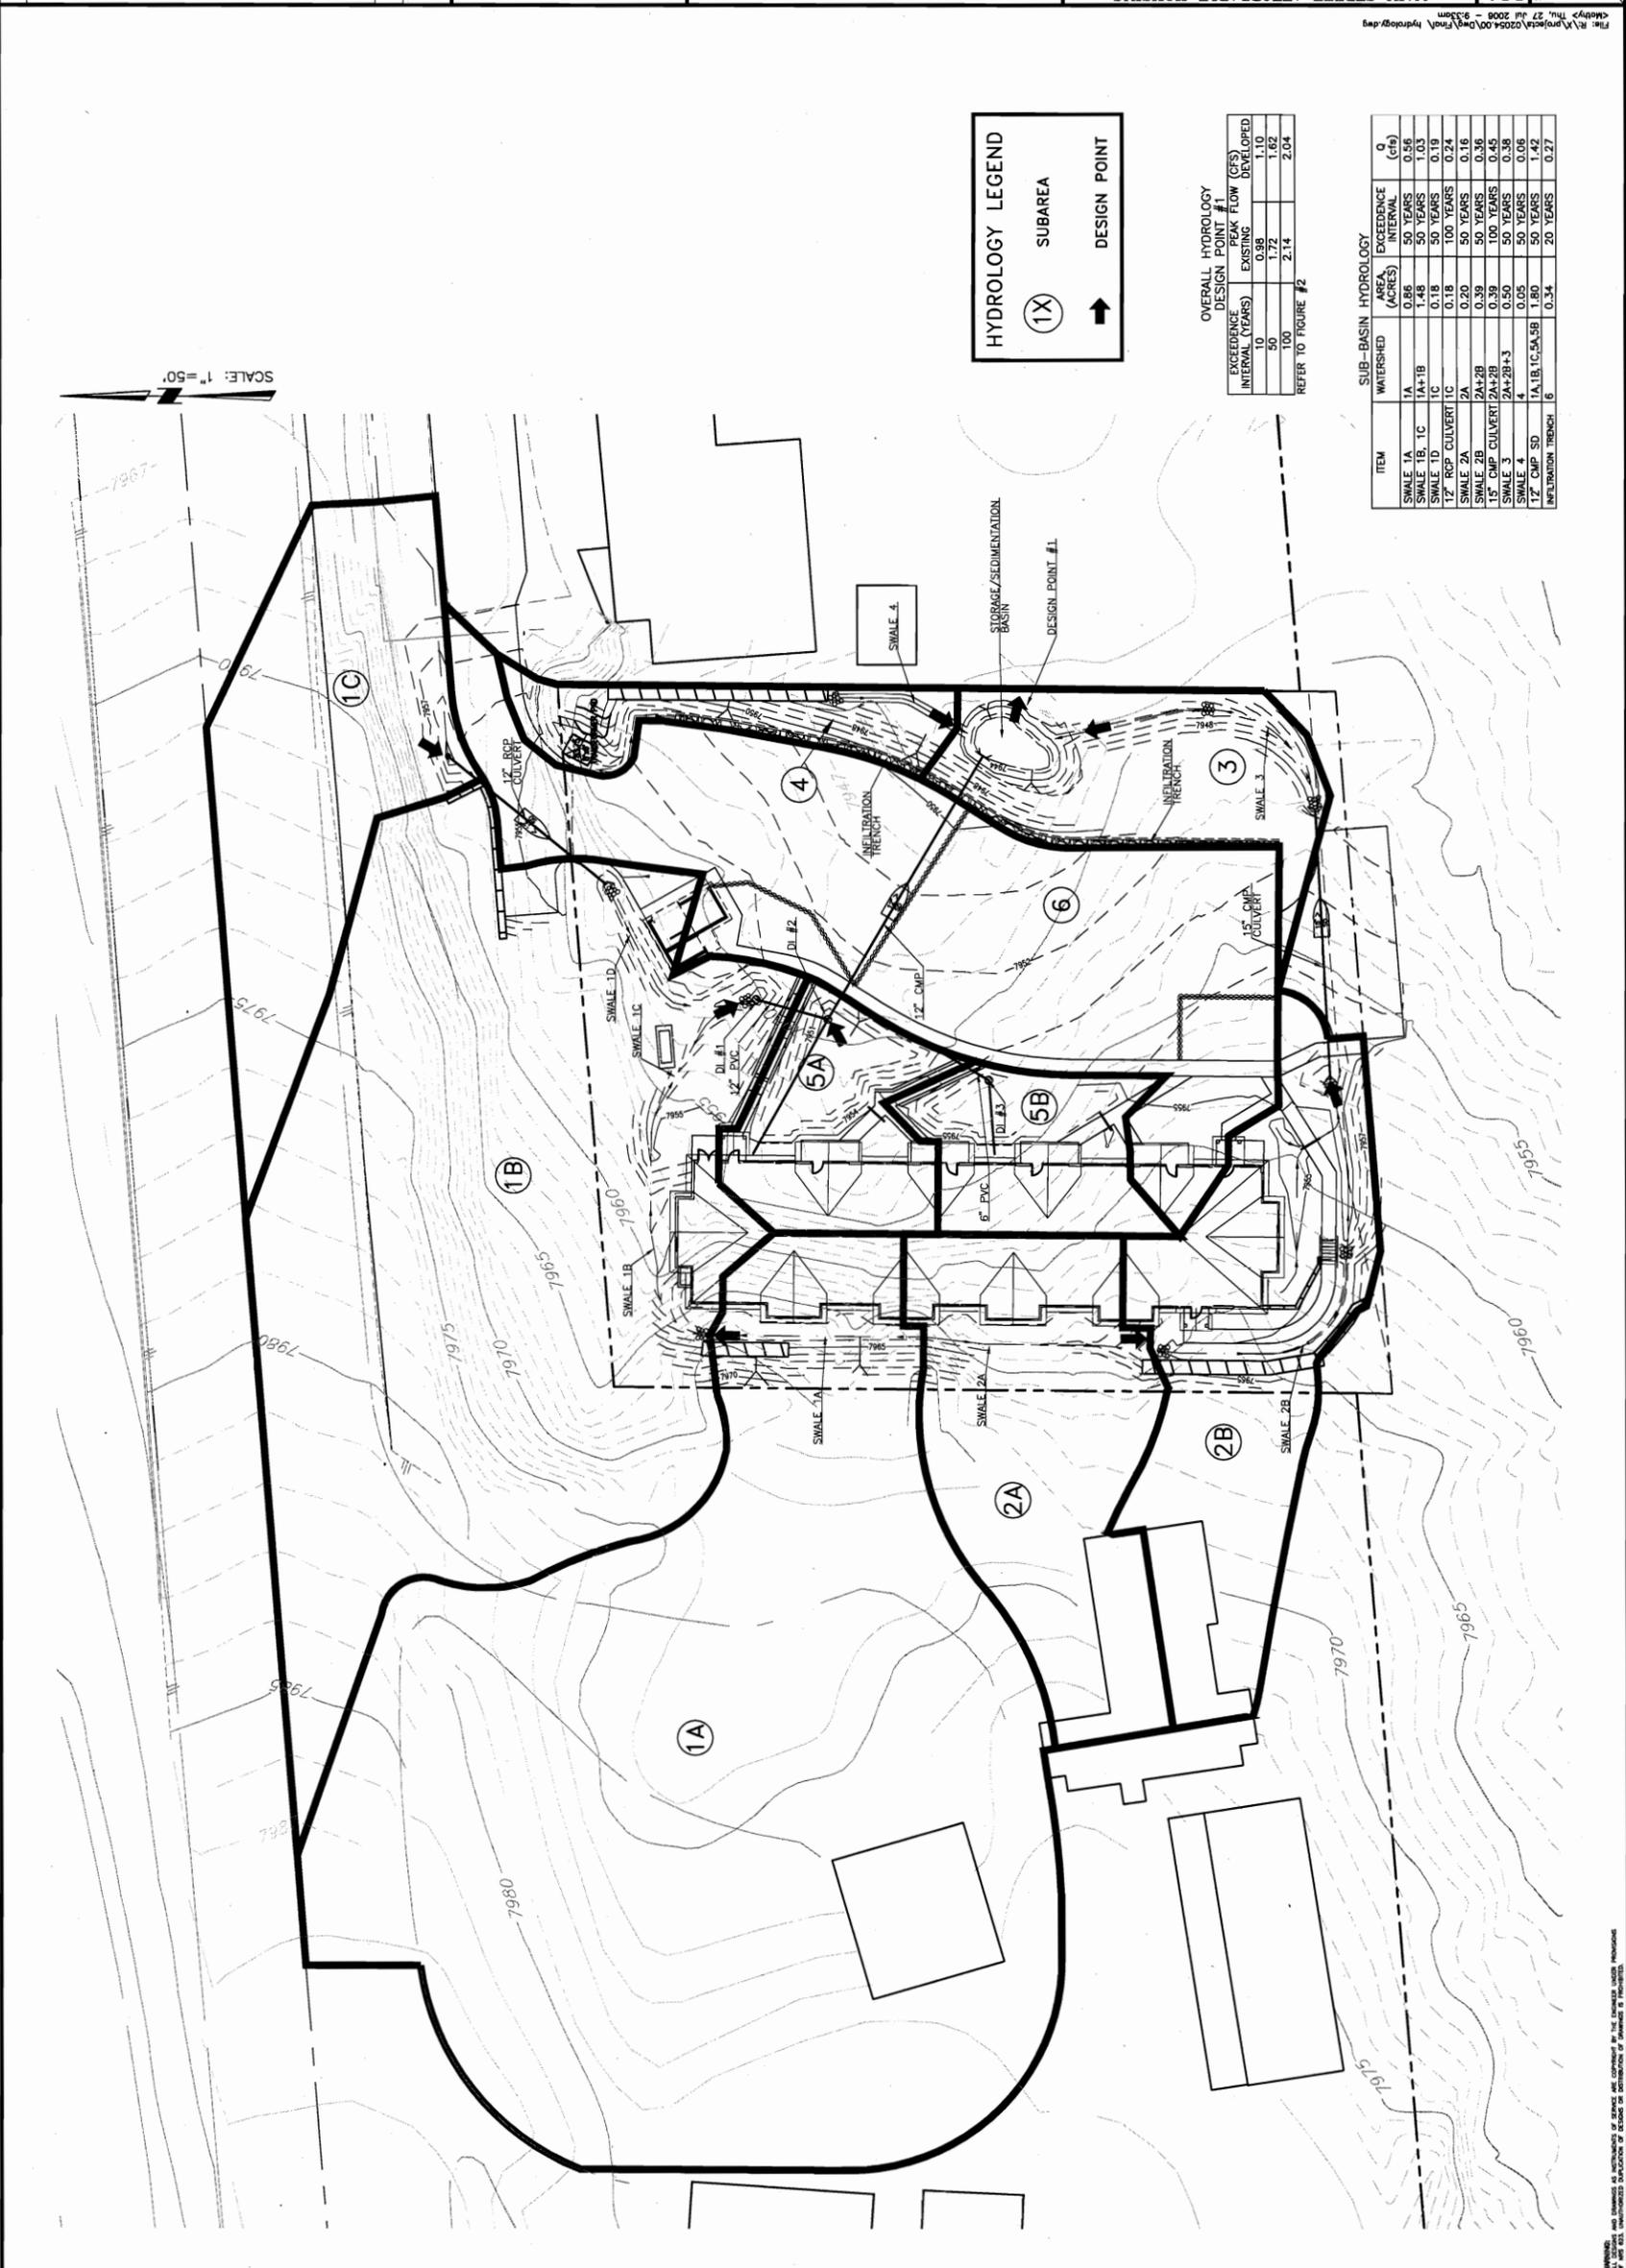
FIGURE 2
 OVERALL HYDROLOGY CONDITIONS MAP
 MAIN STREET AFFORDABLE HOUSING

EXCESSANCE INTERVAL (YEARS)	DESIGN POINT #1	DESIGN POINT #2	DESIGN POINT #3	DESIGN POINT #4	DESIGN POINT #5	DESIGN POINT #6
10	0.98	1.10	1.10	1.10	1.10	1.10
50	1.72	1.62	1.62	1.62	1.62	1.62
100	2.14	2.14	2.14	2.14	2.14	2.14

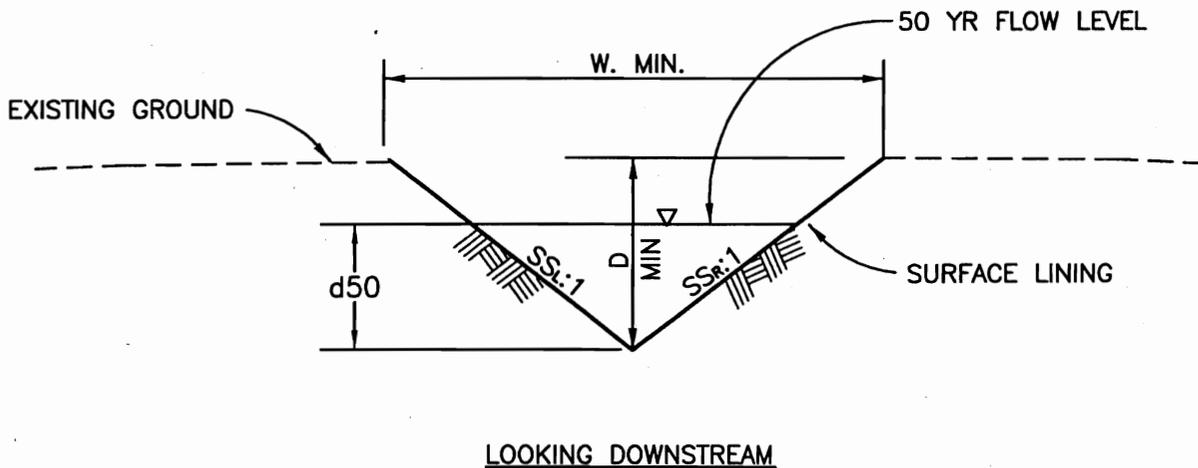
FIGURE 4
DITCHES
MAIN STREET AFFORDABLE HOUSING

1. SLOPES MAY VARY. REFER TO GRADING PLAN
2. SURFACE LINING MAY VARY. REFER TO GRADING PLAN.
3. DEPTH AND WIDTH ARE MINIMUM DIMENSIONS.
4. REFERENCE MAMMOTH DESIGN MANUAL, PAGE 2-13.
5. 10% (10:1) MIN CROSS SLOPE FOR SWALE 1A.

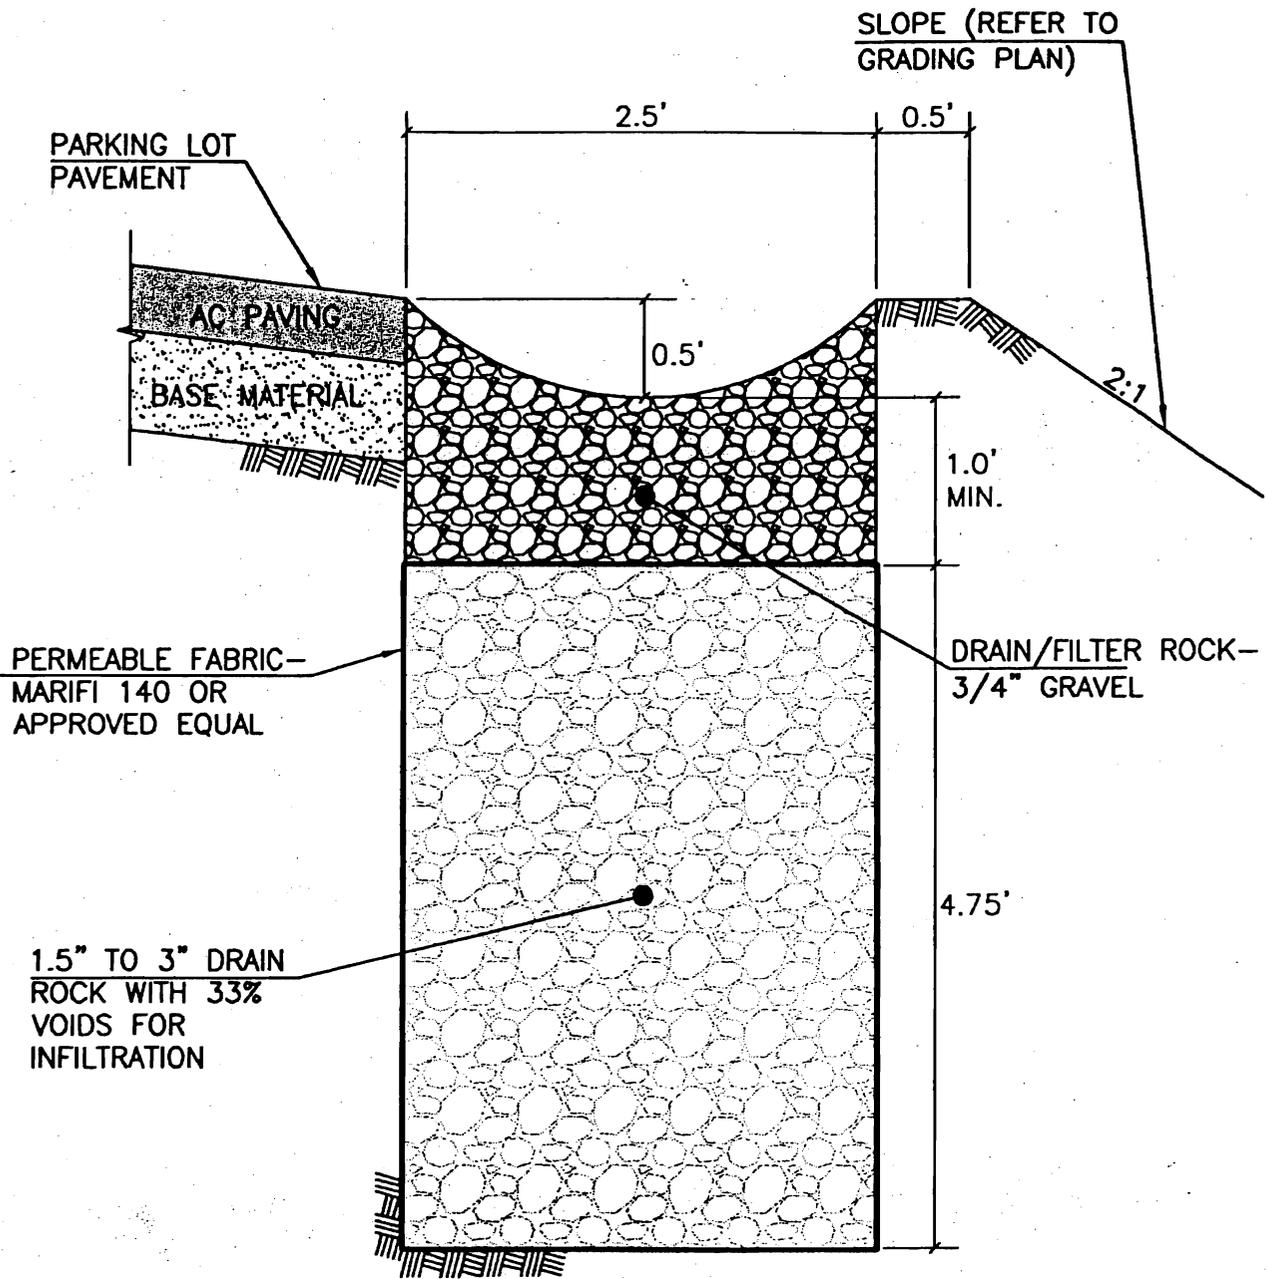
FIGURE 5
INFILTRATION TRENCH
MAIN STREET AFFORDABLE HOUSING

1. The surface type is pavement.
2. The 20 year 1 hour storm needs to be retained per Lahontan Regional Water Quality Control Board. The design intensity per Lahontan RWQB is 1.0 in/hr (0.083 ft/hr)

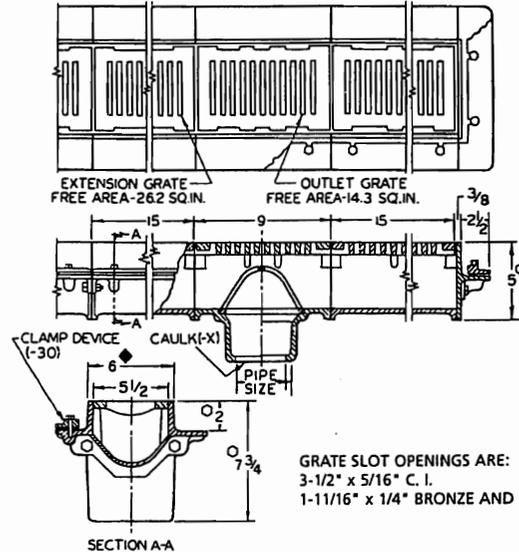
GRATE SLOT OPENINGS ARE:
3-1/2" x 5/16" C. I.
1-11/16" x 1/4" BRONZE AND NIKALOY

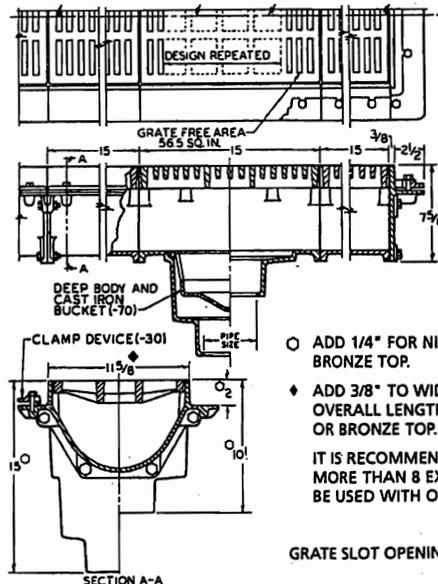
- ADD 1/4" FOR NIKALOY OR BRONZE TOP.
 - ◆ ADD 3/8" TO WIDTH AND OVERALL LENGTH FOR NIKALOY OR BRONZE TOP.
- IT IS RECOMMENDED THAT NO MORE THAN 8 EXTENSION SECTIONS BE USED WITH ONE OUTLET SECTION.
